Manhole Inspection Summary

Manhole # S53C__002MH

Location Address: **3333 e fayette st**

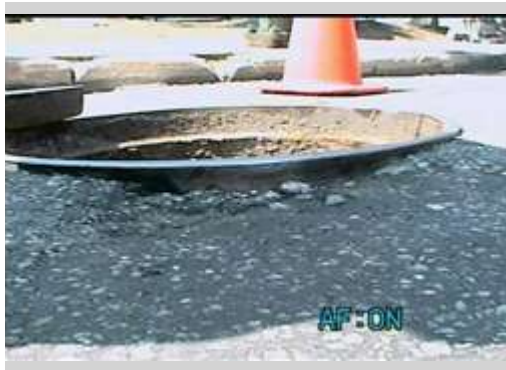
Miscellaneous

Diameter: **26** (in.) Length: **0** (in.) Dist A/B Grade: **1** (in.)

above grade

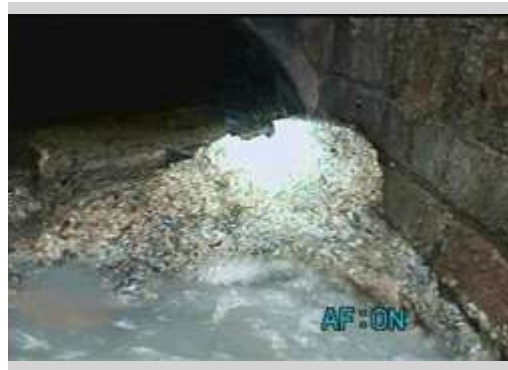
Defect 6

Condition: ☐ Sound ☐ Cracked ☐ Root Intrusion ☐ Deteriorated ☐ Leaks ☒ **Debris**

channel debris

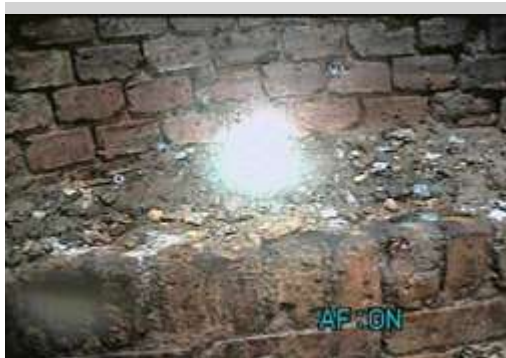
Defect 5

Condition: ☐ Sound ☐ Cracked ☐ Root Intrusion ☐ Deteriorated ☐ Leaks ☒ **Debris**

bench debris

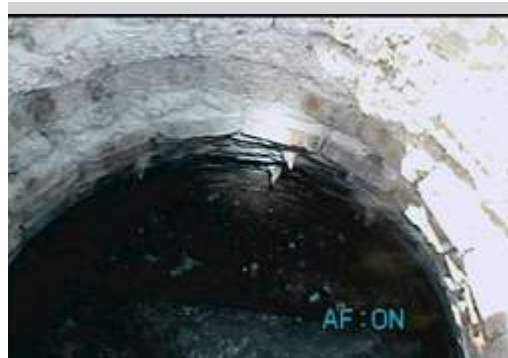
Defect 4

Count: **2** Missing: **2** ☒ **Corroded**

corroded and 2 missing steps

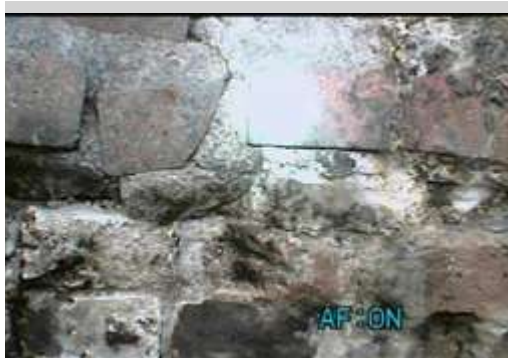
Defect 3

Condition: ☐ Sound ☐ Cracked ☐ Root Intrusion ☒ **Loose Brick** ☒ **Deteriorated**

loose bricks and deteriorated corbel

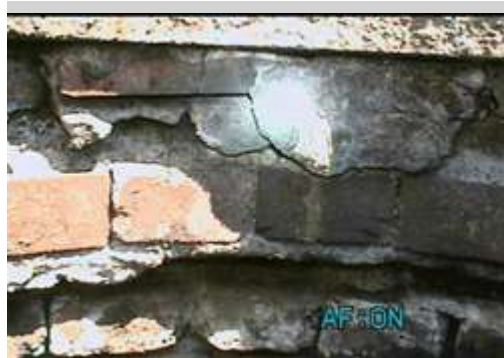
Defect 2

Condition: ☐ Sound ☐ Cracked ☐ Root Intrusion ☒ **Loose Brick** ☒ **Deteriorated**

chimney cond loose bricks and
deteriorated, frame adj

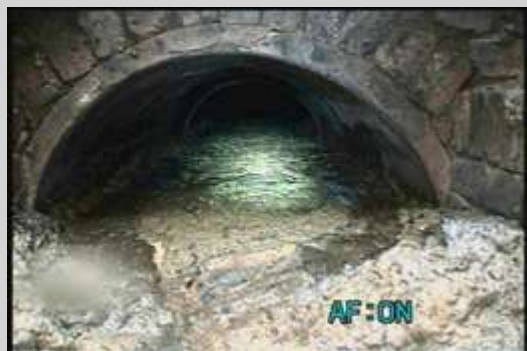
6 O'Clock Inflow

24 in. Circular Gravity Sewer
Pipe In @ 6 O'Clock

Invert Depth: **6.53** (ft.) Flow Characteristics: **Slow**

Deposits: ☐ None ☐ Mud ☒ **Sludge** ☐ Debris ☐ Grease

Silt Depth: **4** (in.) Deposits Extent: **Light**
